# Manhole Inspection Summary

Manhole # S29A\_\_032MH

Insp Date: **4/22/09 11:06 AM**

**Location** Address: **901 ARGYLE AVE**

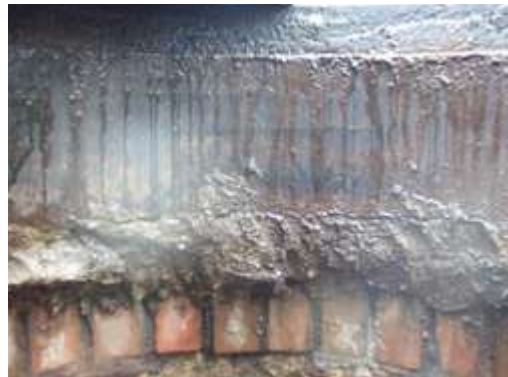
Defect 1

Infiltration: ☐ None ☒ **Joint** ☐ Cracks ☐ Mortar ☐ Roots ☐ Wall

INFILTRATION IN CHIMNEY

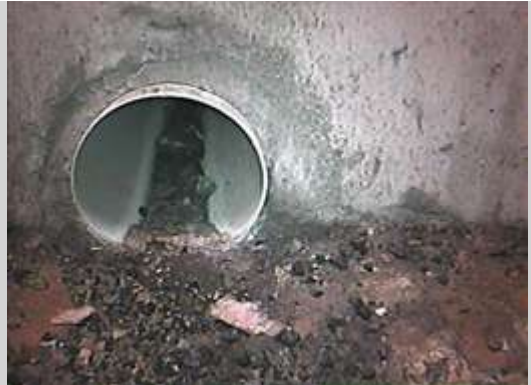
12 O'Clock Outflow

8 in. Circular Gravity Sewer  
Pipe Out @ 12 O'Clock

Pipe Material: **PVC** ☐ Pipe Lined

Infiltration: **None** Pipe Seal Cond: **Sound**
